# UNDERWATER BRIDGE INSPECTION REPORT

STRUCTURE NO. 62555

WABASHA AVENUE

MINNESOTA DEPARTMENT OF TRANSPORTATION  
UNDERWATER BRIDGE INSPECTION

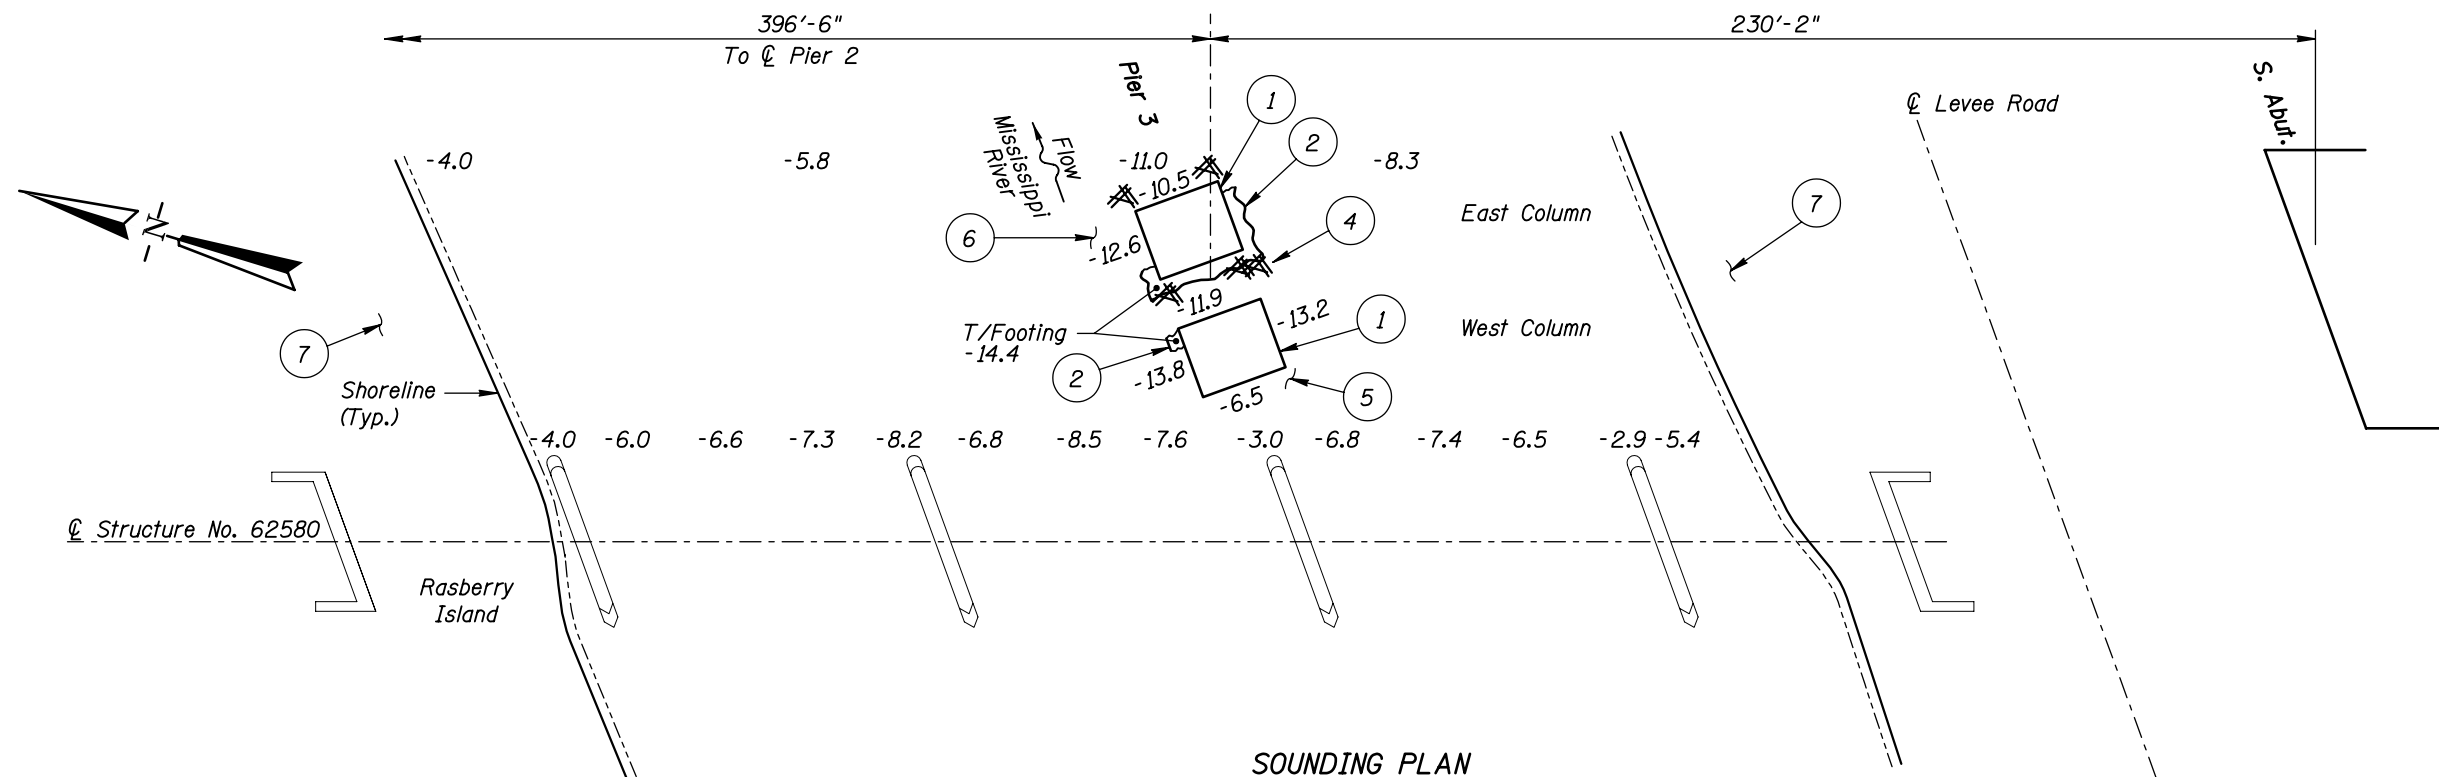
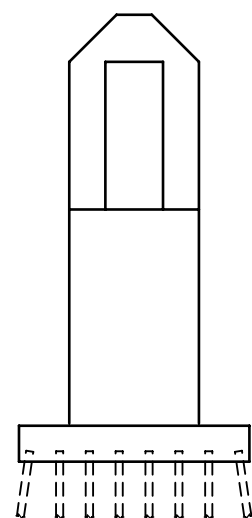
**INSPECTION AND SOUNDING PLAN**

- 1 The concrete was in good and sound condition with no structurally significant defects observed.
- 2 A 3 foot diameter portion of the top of the footing was exposed at the northeast corner of the West Column.
- 3 A 6 foot wide portion of the top of the footing was exposed from the downstream quarter point on the south side extending up and along the entire upstream side at the East Column.
- 4 A minor accumulation of timber debris, consisting of 12 inch diameter logs, was observed at the upstream and downstream ends of the East Column.
- 5 The channel bottom consisted of riprap up to 1 foot in diameter at the upstream nose of the West Column.
- 6 The channel bottom consisted of sandy infilling with up to 1 foot of probe rod penetration.
- 7 The embankments were well armored with 1 foot diameter riprap.

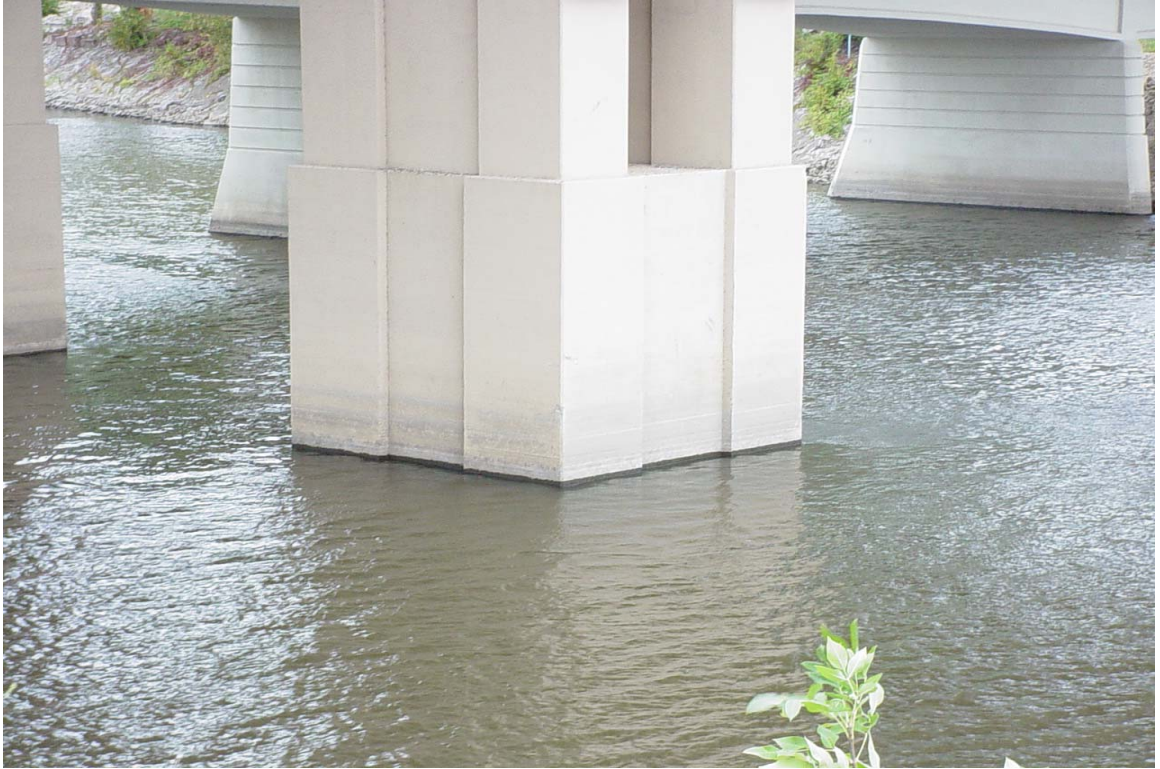
Photograph 3. View of the East Column of Pier 3, Looking Northwest

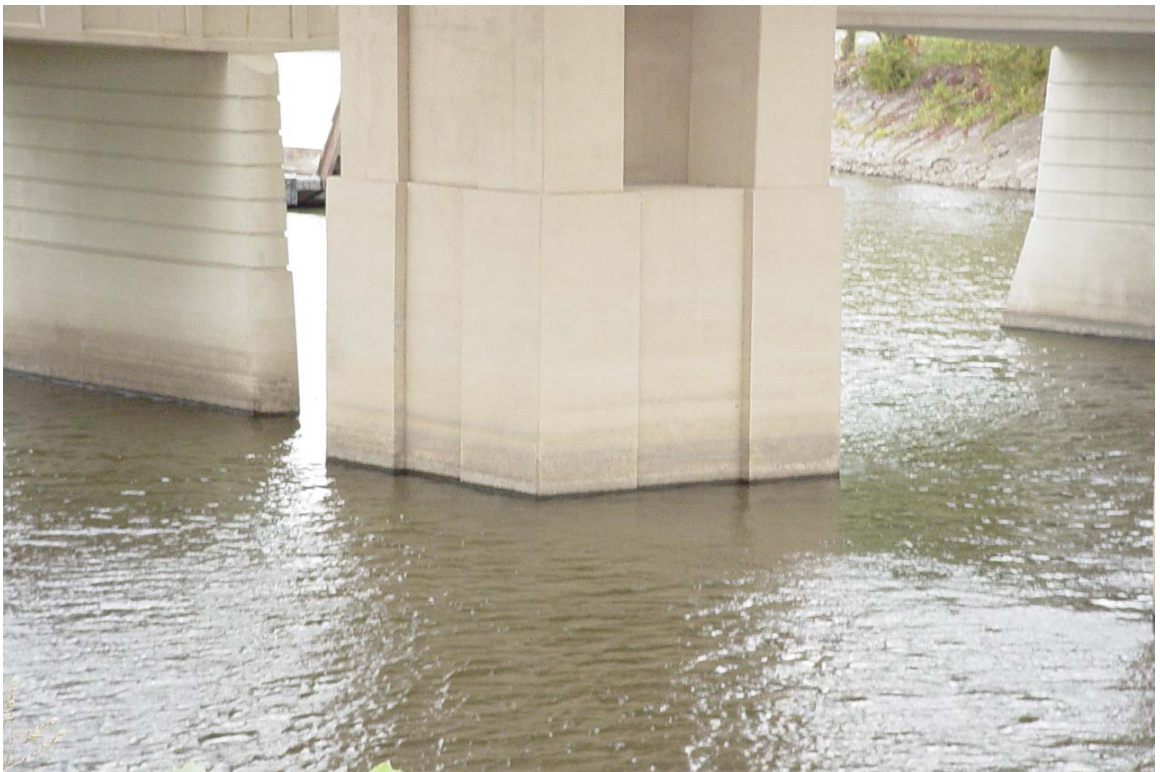
Photograph 4. View of the West Column of Pier 3, Looking Northwest

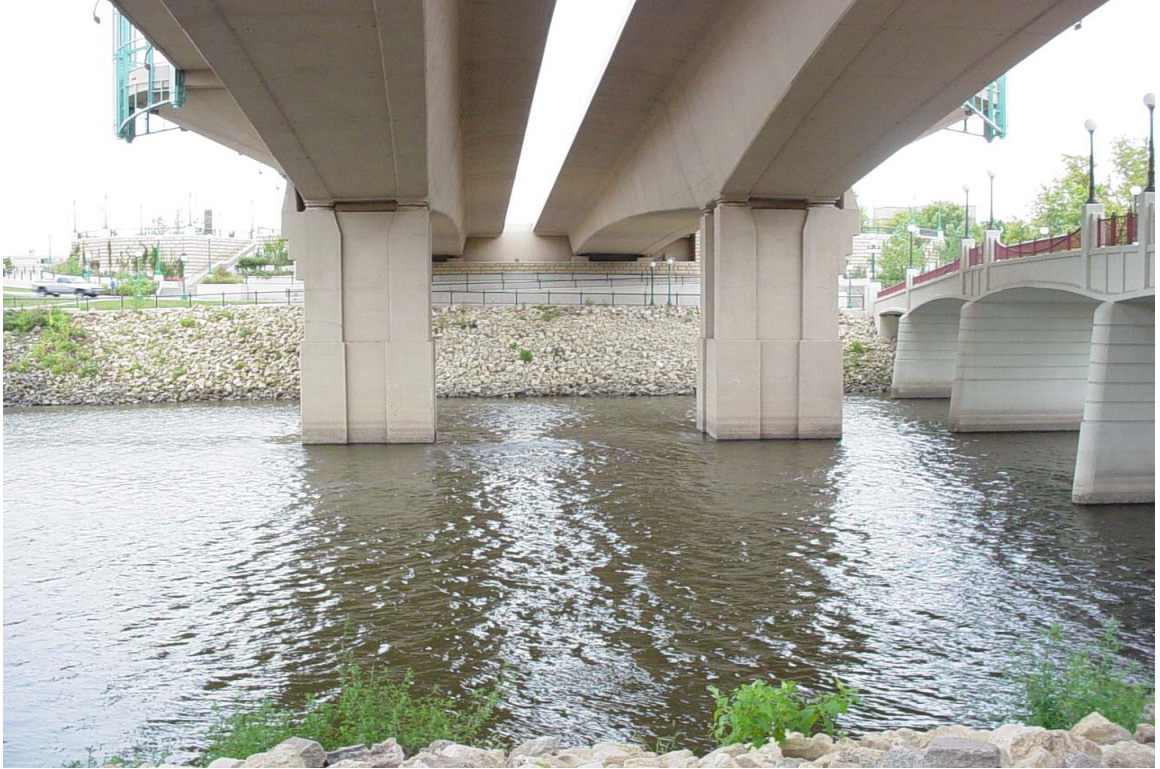
Photograph 5. View of Pier 3, Looking South
